**SAS Superstructure**

**Daily Diary Report by Bid Item**

Contract No.: 04-0120F4

Diary #: 302 Const Calendar Day: 981 Date: 16-May-2012 Wednesday

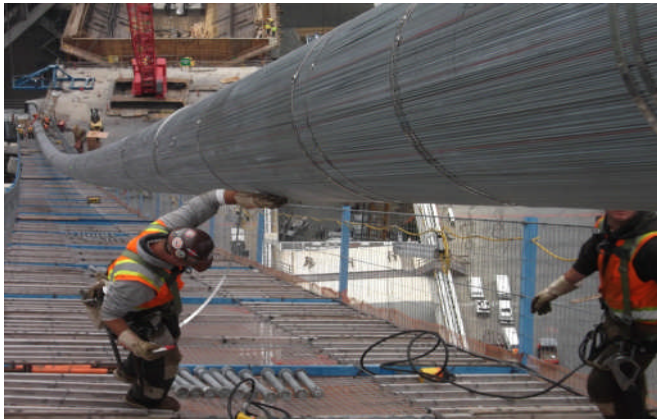
- From 10:30 until 12:15, installation of the CB at PP 38S was done. Note: I was present for only about half of the installation because I had to go to a meeting. I saw that the Cable was cleaned prior to starting installation (see attached photo), & the only the rough setting of the CB.

Solvent cleaning Cable prior to CB installation
